Laboratory Simulation of Rolling Contact Fatigue Cracks in Wind Turbine Bearings Using Hydrogen Infused 100Cr6 Bearing Steel

S. Janakiraman^{1*}, O. West¹, P. Klit¹, N. S. Jensen¹

¹Technical University of Denmark, Nils Koppels Alle, bld. 404, 2800 Kgs. Lyngby, Denmark.

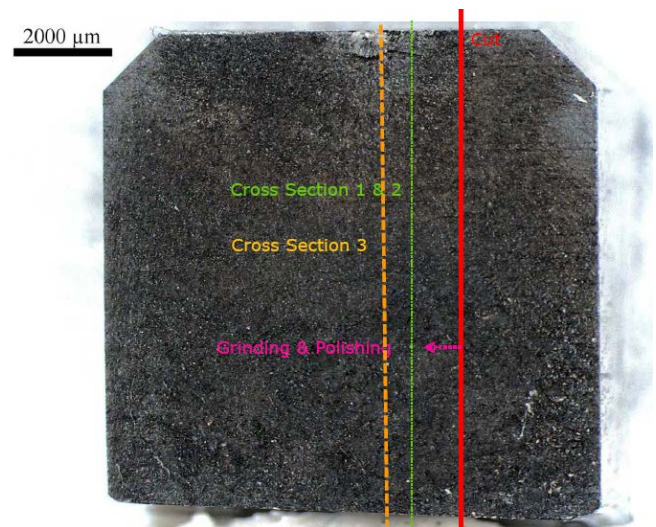
Figure 2 : Stereomicroscope image of the fracture surface of ring B1

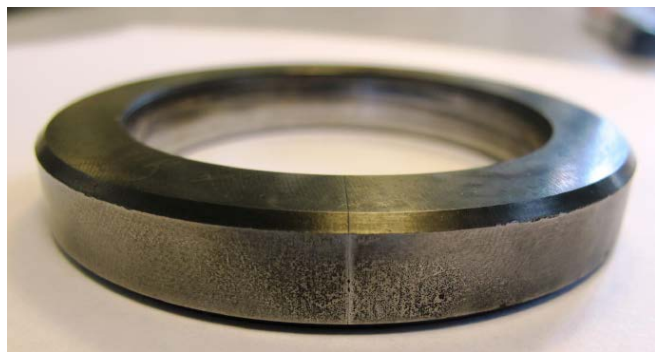
Figure 3 : Axial crack on ring B1.

(**Fig. 3**) and (**Fig. 4**) show the fracture surfaces of the ring B1 that fractured after 11 million cycles. A cross

material is similar to the material of the test ring specimens used for testing. These cracks look similar to the axial crack on the surface of the ring B1 (**Fig. 3**). The failed bearing inner ring from service are sectioned, polished, etched and viewed under a microscope. Their failure characteristics are then compared to the failure characteristics in the laboratory simulated RCF rings.

(**Fig. 3**) and (**Fig. 8**) also show pitting on the surface of the test specimen. Pitting could occur due to the presence of small solid contaminants in the lubricant, or due to a subsurface cracks growing to the surface.

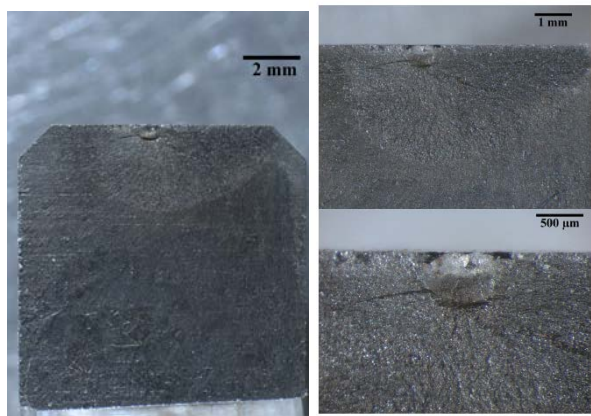
Figure 4: Stereomicroscope images of the fracture surface of ring B1

(**Fig. 4**) and (**Fig. 5**) shows a resemblance to the fractured sample in the ball bearing fatigue test conducted by Clark [2]. The fracture surface shows a difference in texture between the top and bottom of the specimen. The rough, rounded portion close to rolling surface appears to have fractured by fatigue while the smooth lower portion appears to have fractured in a brittle manner.

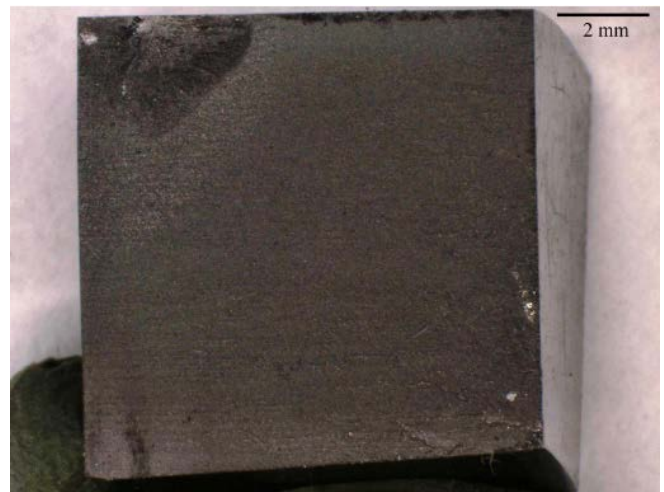
Figure 5: Stereomicroscope image of the fracture surface of the ring A2

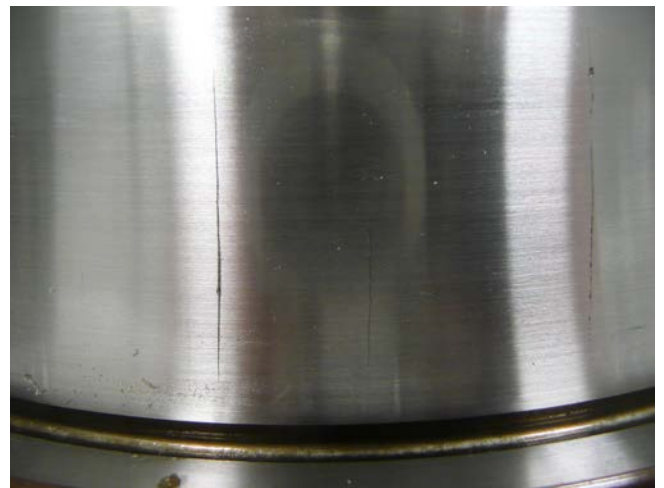
Figure 6: Axial crack on the inner ring of a bearing from service

(**Fig. 6**) shows multiple axial cracks on the inner ring of a tapered roller bearing from service. The bearing was positioned on the shaft at the intermediate stage inside the gearbox of a wind turbine. The gearbox belonged to a 2.3 MW turbine. The material is a through-hardened martensitic bearing steel. This

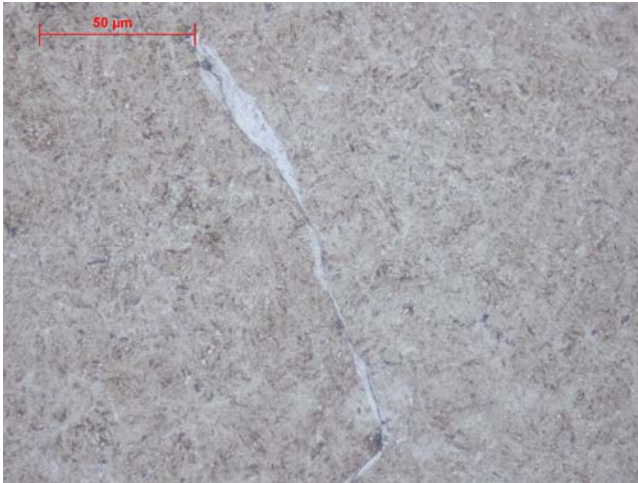
Figure 7: RLM image of a nital etched axial cross section (cut parallel to the over-rolling direction) showing a White Etching Area(WEA) around a crack in the inner ring of the bearing.

(**Fig. 7**) shows a characteristic WEA around a crack in an axial cross section of the bearing inner ring surface. It has been suggested by Kino et al., [6] that hydrogen plays a role in the formation of these WEA. Uyama [6] studied these WEA using a Transmission Electron Microscope (TEM) and observed that the white structure consisted of an ultra fine grained structure. He further suggested that the localized microstructural changes are caused by the hydrogen and hence supposed that the basic role of hydrogen is to localize plasticity.

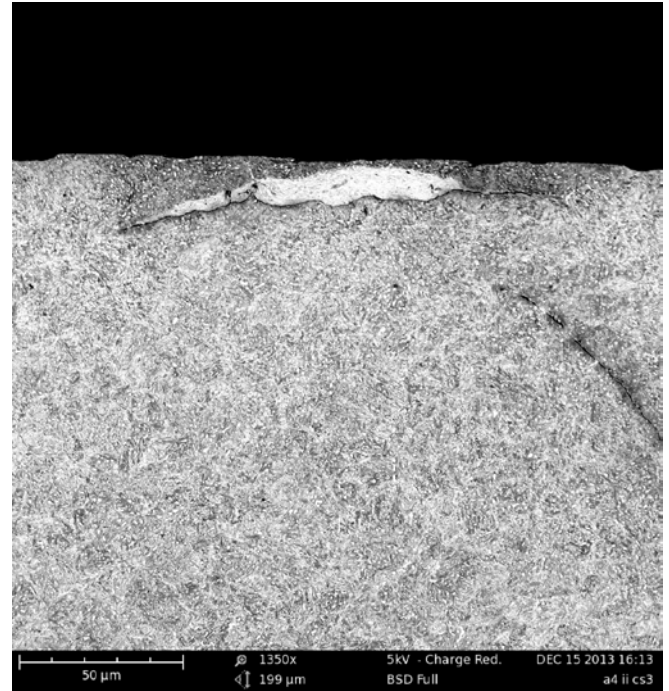
(**Fig. 8**) shows a WEA found in an axial cross section near a crack formed subsurface. This crack is less than 20 microns from the rolling surface. This is believed to be because raised levels of hydrogen closer to the rolling surface, weaken the material and make it more susceptible to crack initiation. Evans [5] showed that decreasing the levels of hydrogen artificially infused in the surface of the ring causes these cracks to be formed much further away below the rolling surface.

Figure 8: WEA found near a crack on the failed lab specimen B2
